**Subject:** Re: [FT817] Re: finals-THE FIX!!!

I have discovered that under some conditions, the FT-817 may be susceptible to an INTERNAL OSCILLATION of the final and driver stages, which will result in excess current being drawn, and POSSIBLE damage to the affected stages.

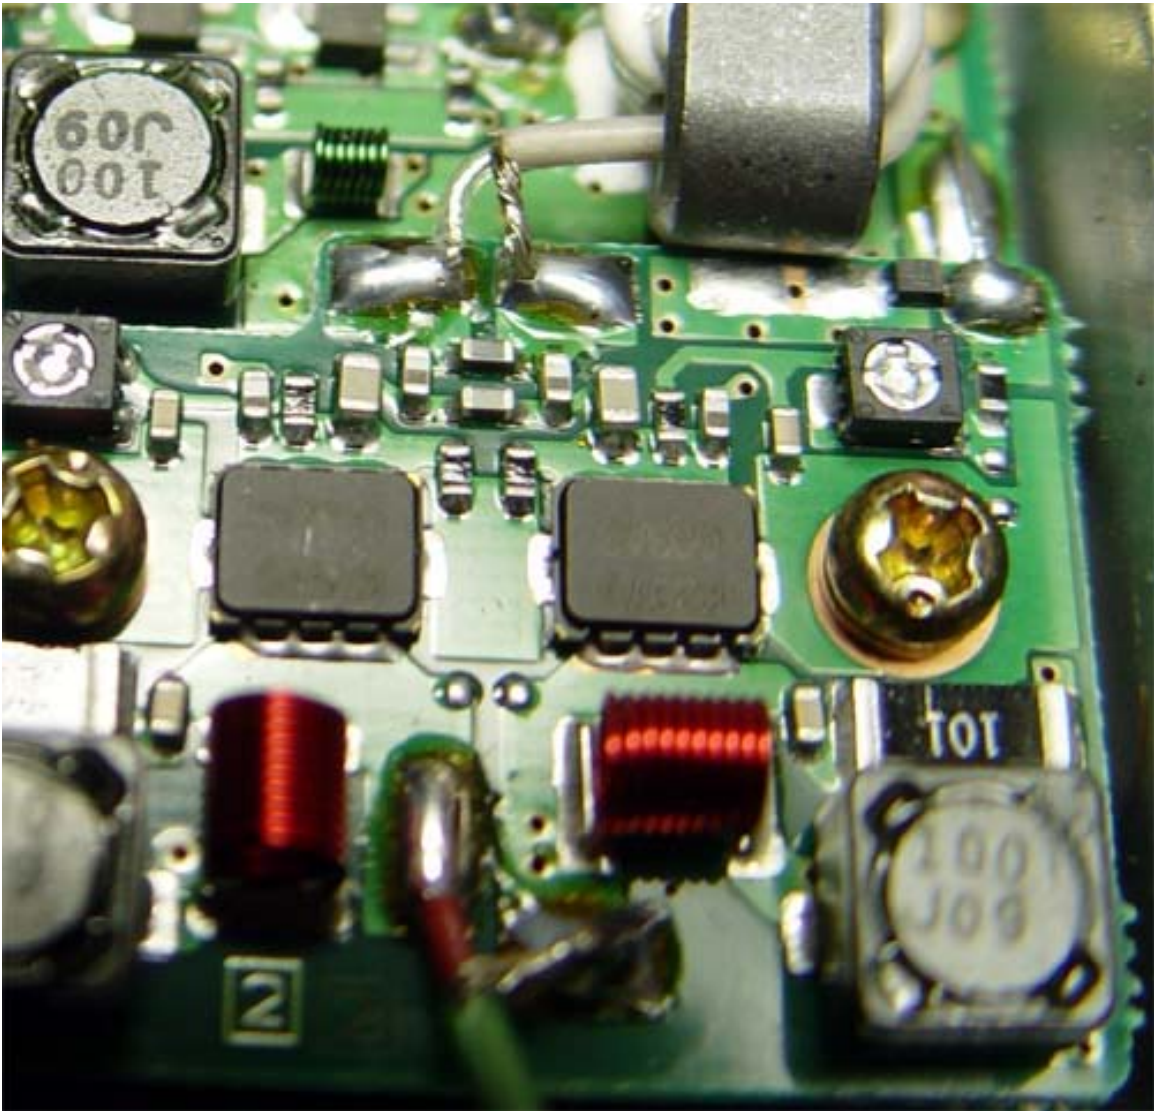
Here is a picture of my FT-817 PA board before the mod. Note the grey wire coming out of the Balun and which wire goes where

I ALSO have determined that this problem can be solved by simply REVERSING the PHASE of the drive signal to the input of the final output board, and this is one by un-soldering and reversing the shielded cable from the driver stage output balun, at the input to the final board.

It DOES take a good eye, steady and, proper tools, and a little skill to SAFELY and properly accomplish. (You simply swap the shield and center conductor connections of the input coax to the final board)--Do this at ONLY the final board end. The coax COLOR on the correct balun is grey/white-NOT the blue one!

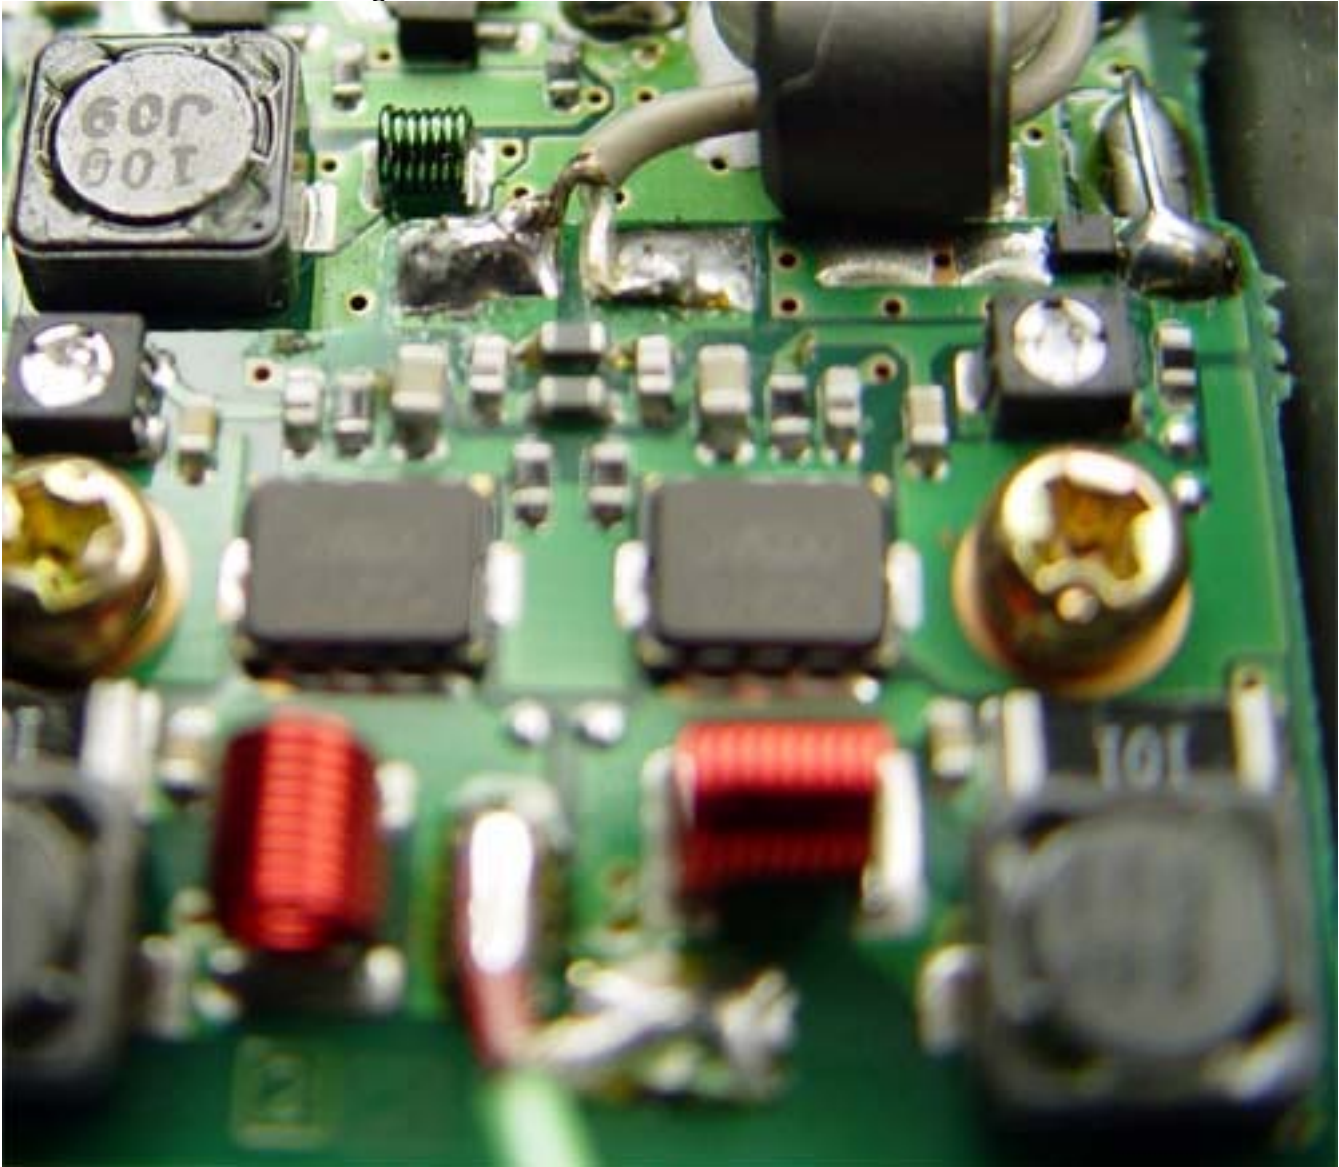
Here is a picture of my FT-817 PA board after the mod. Again, note the grey wire coming out of the Balun and which wire goes where

Once the modification is complete, as further insurance, I advise checking the final stage IDLING BIAS current. This may be done by un-soldering the 13.8 volt bare wire power jumper from the P.A.(final) board, and connecting a milliamperemeter in series, to read the idling current. The radio should be connected to an EXTERNAL power source of 13.8 volts D.C. and operated in the SSB mode with NO AUDIO input (Turn SSB mike gain menu to ZERO)-When you energize the PTT circuit, in SSB mode, with no audio, you SHOULD see a current of 70 to 90 milliamperes, and if you adjust the bias pots, one at a time, COUNTERCLOCKWISE on the final board, each pot should take it DOWN to approximately 1/2 the value previously noted. (35 to 45 milliamperes each),for the TOTAL of 70 to 90 ma. (If all is normal, RETURN the pots to their original setting. Do NOT exceed 100 milliamperes when adjusting!)
